Seafloor Debris Mapping

Solent Forum
24th April 2024

Map seafloor debris within Solent Maritime SAC (112km²)

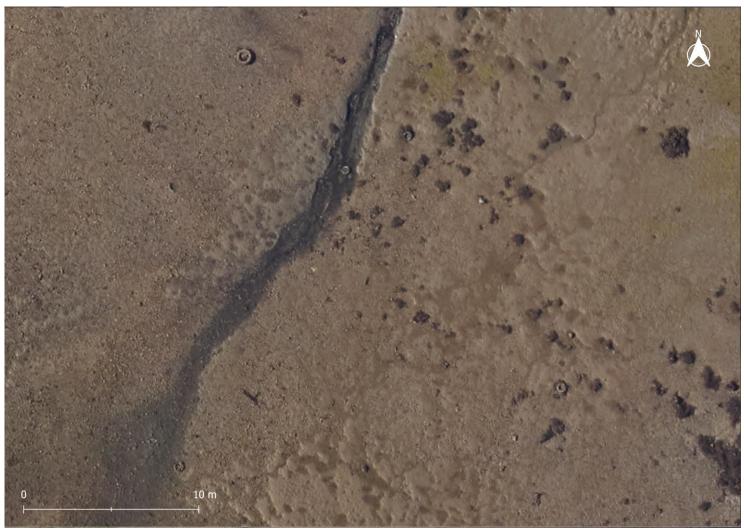
Aerial Imagery Analysis

Abandoned Boats
Abandoned Anchors
Structures
Scrap Metal / Pipes
Tyres
