Re-COMP PILOT 2024

Report on the Pilot Project for the Disassembly, Recycling and Upcycling of End of Life (EOL) Vessels - July 2024

Led by South Hams District Council in partnership with Blue Parameters Ltd, Creekside Boatyard, and South Devon College

Report prepared by Blue Parameters Ltd [July 2024]

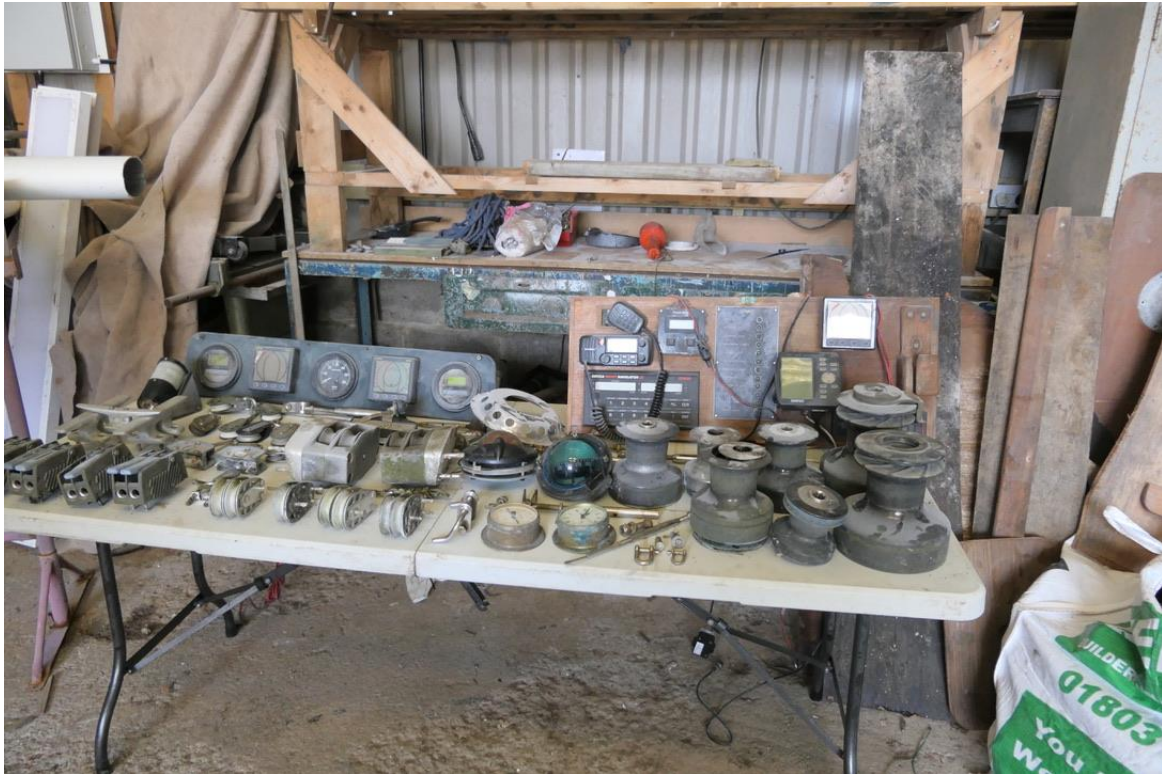
Recovered Deck Hardware and Electronics

It is clear from the images below, that a high proportion of the vessels ancillary and operating equipment was removed intact.

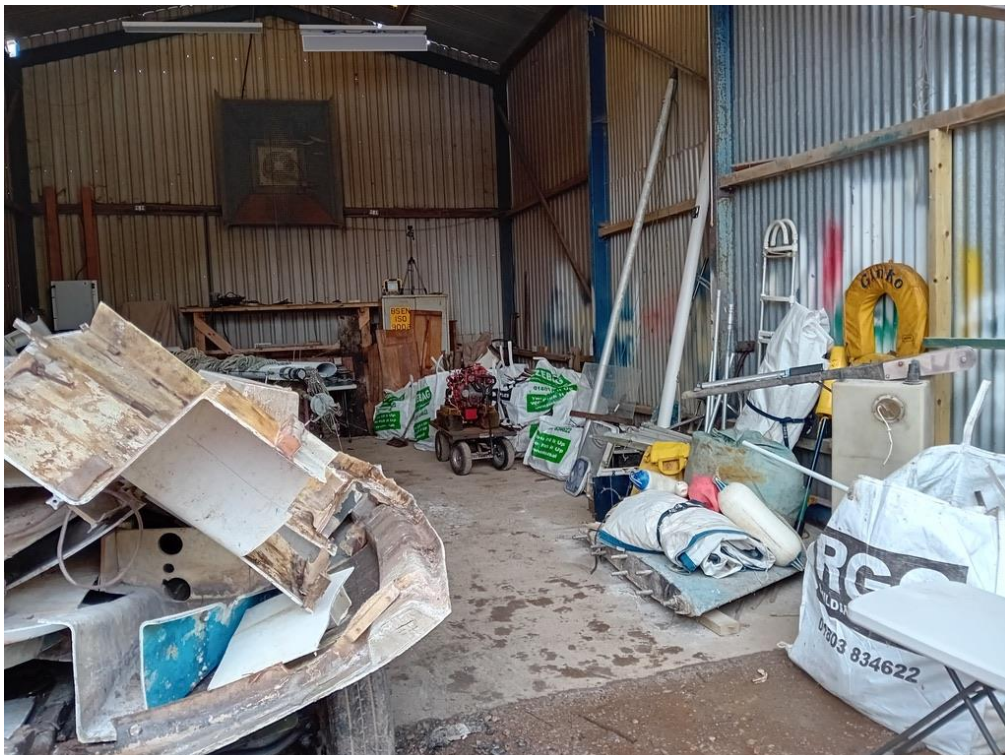
Sails, Ancillary Gear, Engine and Waste Material

Household and other non-recyclable waste materials are shown in green bags.

The vessel had been left unused and poorly maintained on its mooring for a long period of time. A large quantity of household and other waste (175 Kilos) had accumulated. This was recovered during disassembly and could not be recycled.

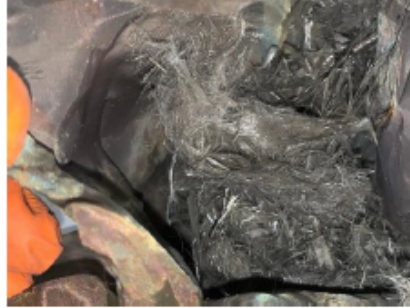
Figure 1: Output material from the upper

The output material from this run differed between the samples in the lower and upper sections of the R&D vessel. The lower samples had no visible change and minimal mass loss, indicating the temperature was too low at this point in the vessel. The upper samples had visibly changed during processing but were still uncomplete. The fibres were still contaminated with organic material, which can be seen by the discoloration present (figure 1).|

section in the 1st run. The mass loss (table 1) reinforced these findings, showing that the samples in the lower section experienced minimal mass change, with the thick piece increasing in mass. It is reasonable to assume that this is due to water ingress. The upper section samples do show significant mass loss, indicating there was success in removing a significant amount of unwanted material. However, visual analysis showed that the desired product had still not been achieved at this mass loss.

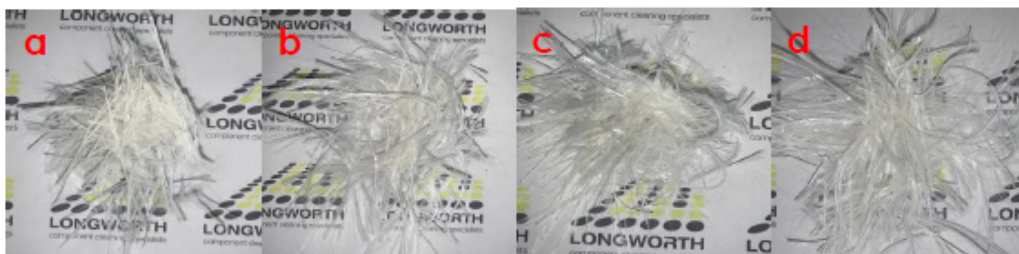
Figure 2: 2nd run output material from a) sample 1 b) sample 2 c) sample 3 d) sample 4

The output material from this run visibly showed liberation of the glass fibres (figure 2). As can be observed, the fibres are now distinguishably white for all the samples, which is a stark difference from the output of run 1 (figure 1). This indicates that the altered processing conditions of the second run were successful in achieving the desired targets of the trial.
