Advanced Mooring Systems (AMS)

LIFE Recreation ReMEDIES: Lessons learned and good practice

Natural England Technical Information Note

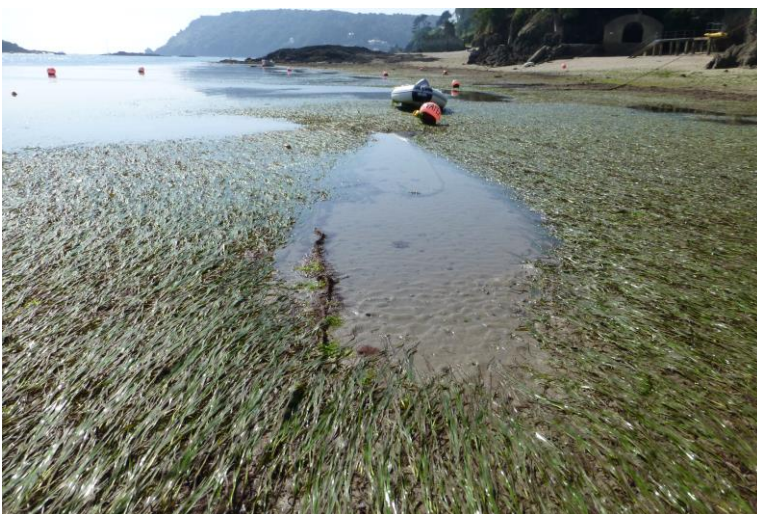
Photo: Damage to seagrass bed from swing mooring in Salcombe Harbour (Keith Hiscock)

Traditional swing moorings are most commonly used in UK waters. The boat is secured to a single buoy and therefore swings in the wind or current. A mooring generally consists of an anchor (or sinker), chain (rode or riser) and float (mooring buoy). A mooring strop is a rope which attaches a boat to the mooring buoy. However, these types of mooring can result in abrasion to sensitive habitats such as seagrass beds. As the tide rises and falls, differing amounts of chain will lie across the seabed, and will be pulled around in a circle as the tide and wind direction changes. Abrasion from the chain causes damage to the surrounding habitat (Griffiths and others, 2017; Unsworth and others, 2017).

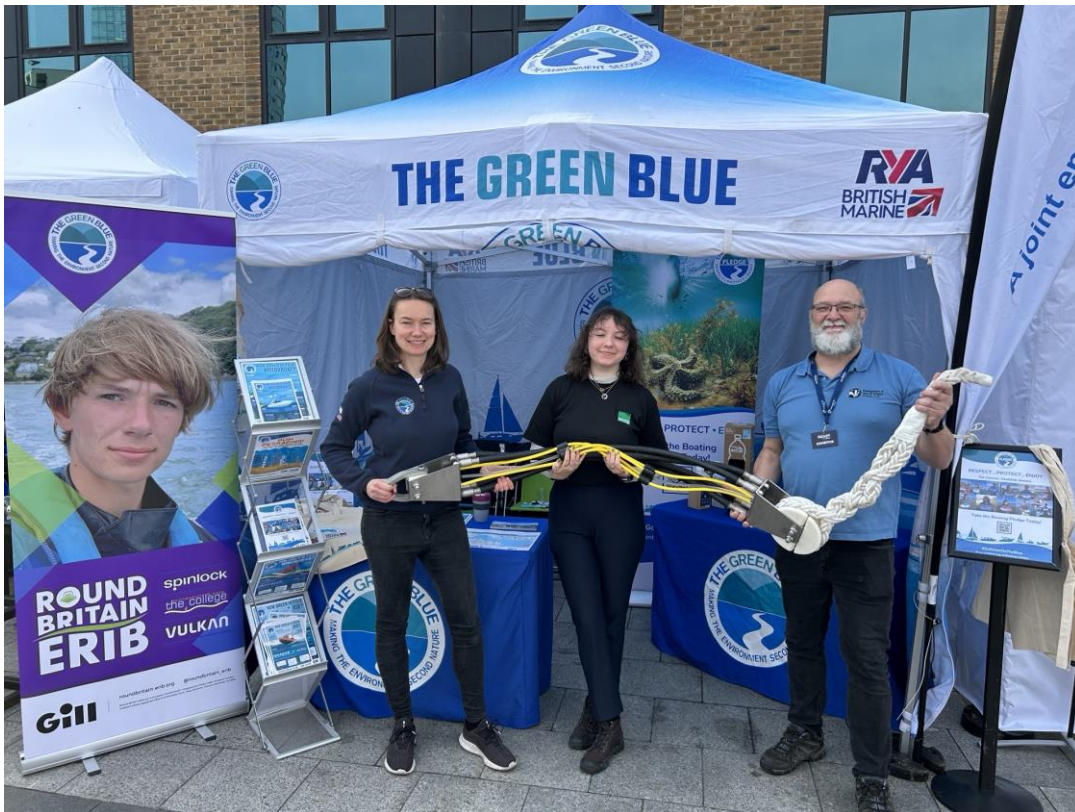
Seaflex is an elastic mooring system that can be used with either mooring buoys or pontoons, and is anchored using either deadweight or embedment anchors. The Seaflex mooring system consists of a reinforced homogenous rubber hawser (cable), built around a homogenous rubber core. A specially braided cord is wrapped around the core, and the outer layer consists of a durable rubber cover which forms the outer shell of the hawser.

Photo: Seaflex mooring being demonstrated at the Green Tech Boat show by staff from The Green Blue, Natural England and Hampshire and Isle of Wight Wildlife Trust (RYA)

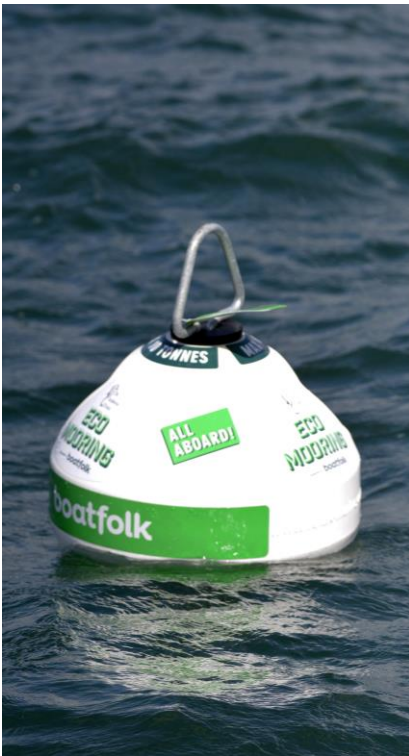
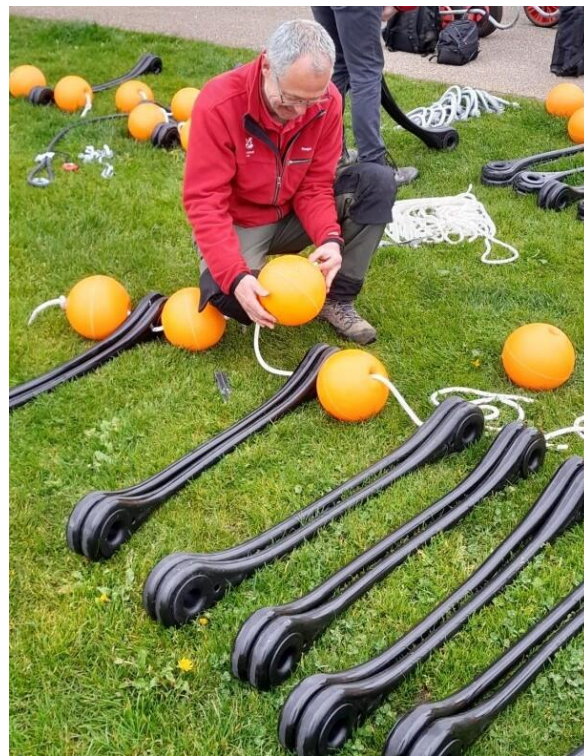
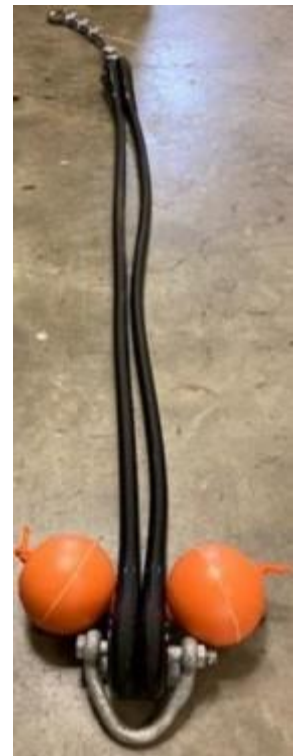
The system consists of galvanised hardware for attaching to a Helix anchor (recommended) or block anchor, hard trawl floats to keep the components afloat, one or more elastic rodes (the line between anchor and boat), a spar buoy, and a stainless steel swivel. The rodes are manufactured from an advanced polyurethane elastomer blend, with polyethylene thimbles (loop of reinforcement) pressed into the ends.

Photo: Hazelett mooring in Studland bay (Left image: Sara Parker (Dorset Council)/middle image: Studland Bay Marine Partnership/right image: Boatfolk)

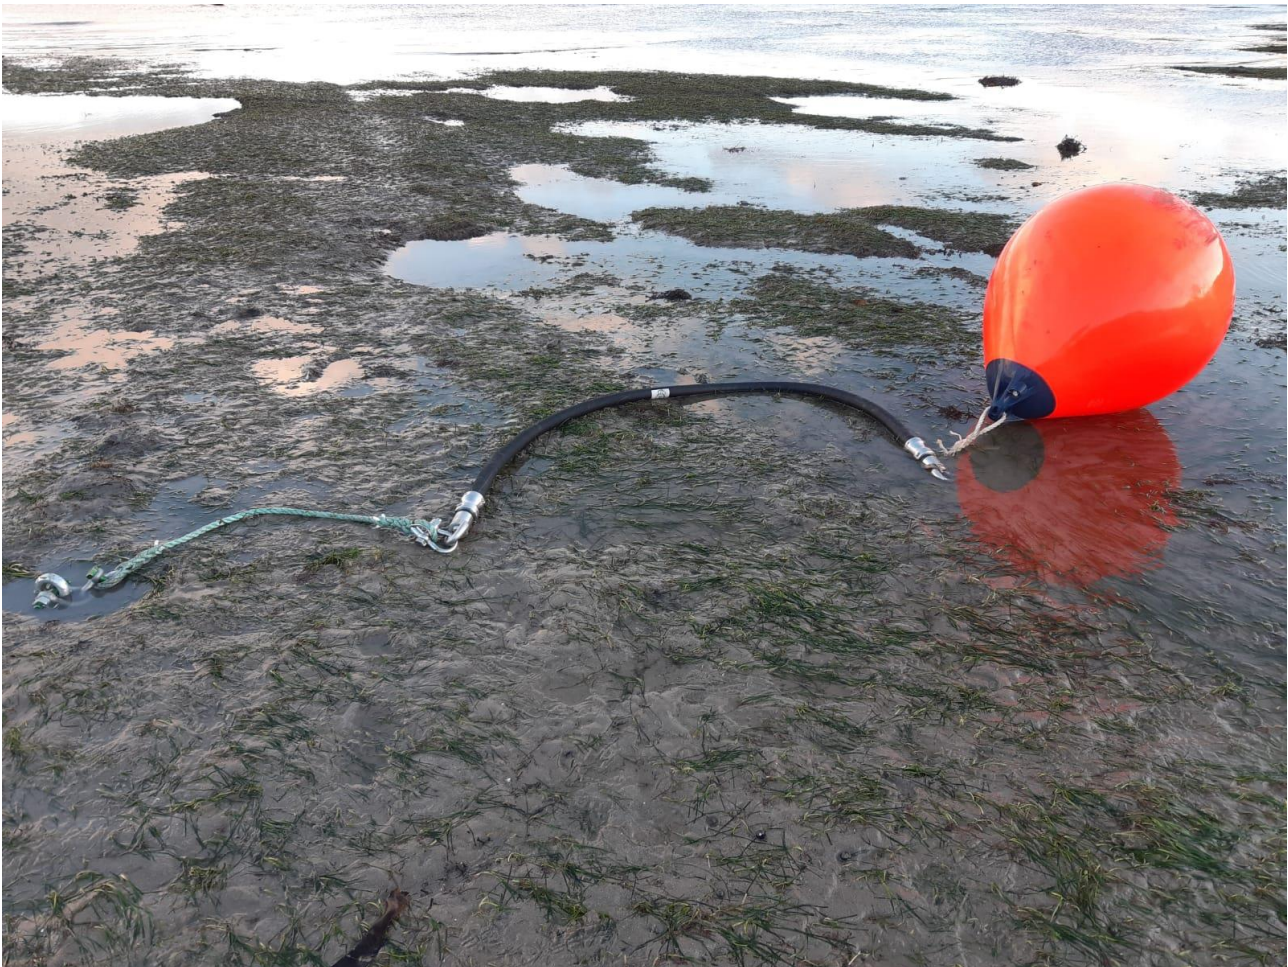
Mooring tether comprised of stretch controlling nylon and vulcanized rubber with aramid (aromatic polyamide - a class of synthetic, high-performance fiber) strengthening the centre core.

Photo: Safemoor system on the intertidal – as a demonstration, due to be moved to a subtidal location. A section of ‘isolating rope’ between shackle connections was used as an option to prevent any issues with dissimilar metals causing corrosion (Alison Hargrave, Pen Llŷn a’r Sarnau SAC).

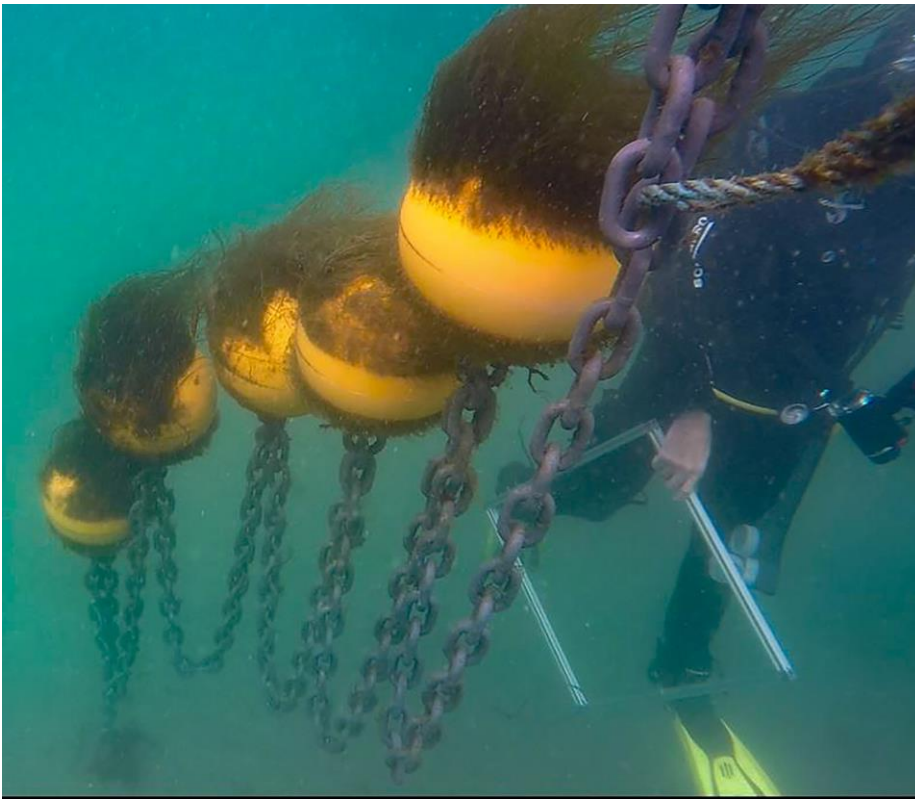
The Stirling design is an adaptation to traditional mooring configurations. It has been developed by the Ocean Conservation Trust in conjunction with Harbour Authorities on the South Coast of England and mooring service providers. The aim has been to create a cost-effective flexible mooring solution by suspending the lower portion of the riser using mid-water floats. Similar designs have been based on this system in other locations.

Photo: Stirling AMS in Cawsand (Plymouth) showing the mid-water floats attached to the riser (Mark Parry, Ocean Conservation Trust).

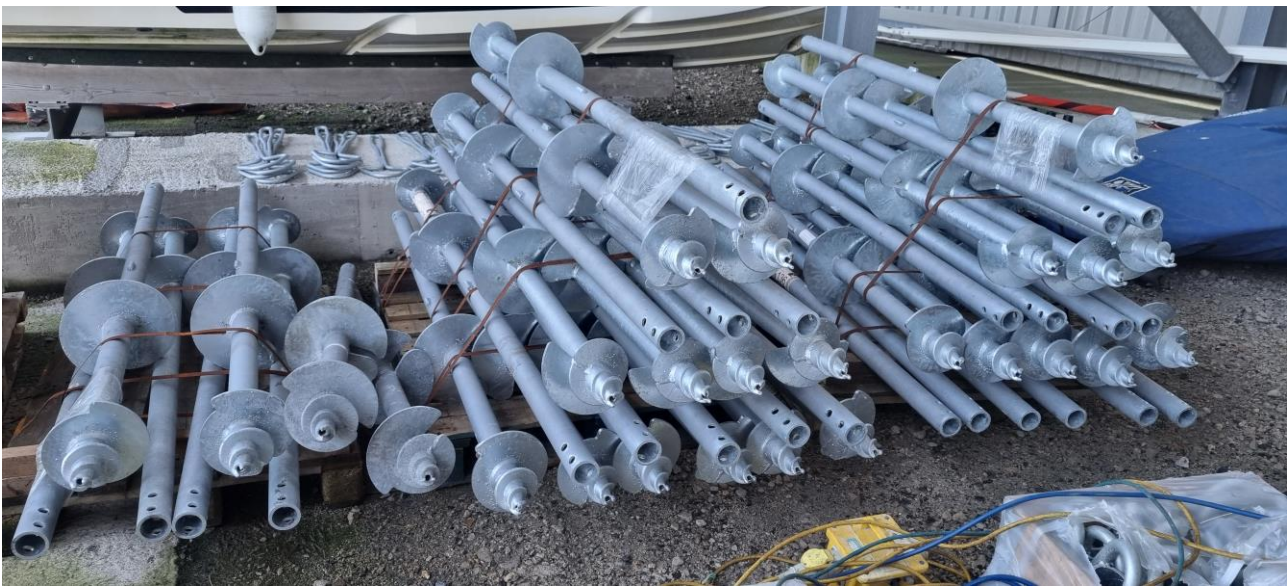
Photo: Screw anchors ready to install with Hazelett moorings in Studland bay (Studland Bay Marine Partnership)

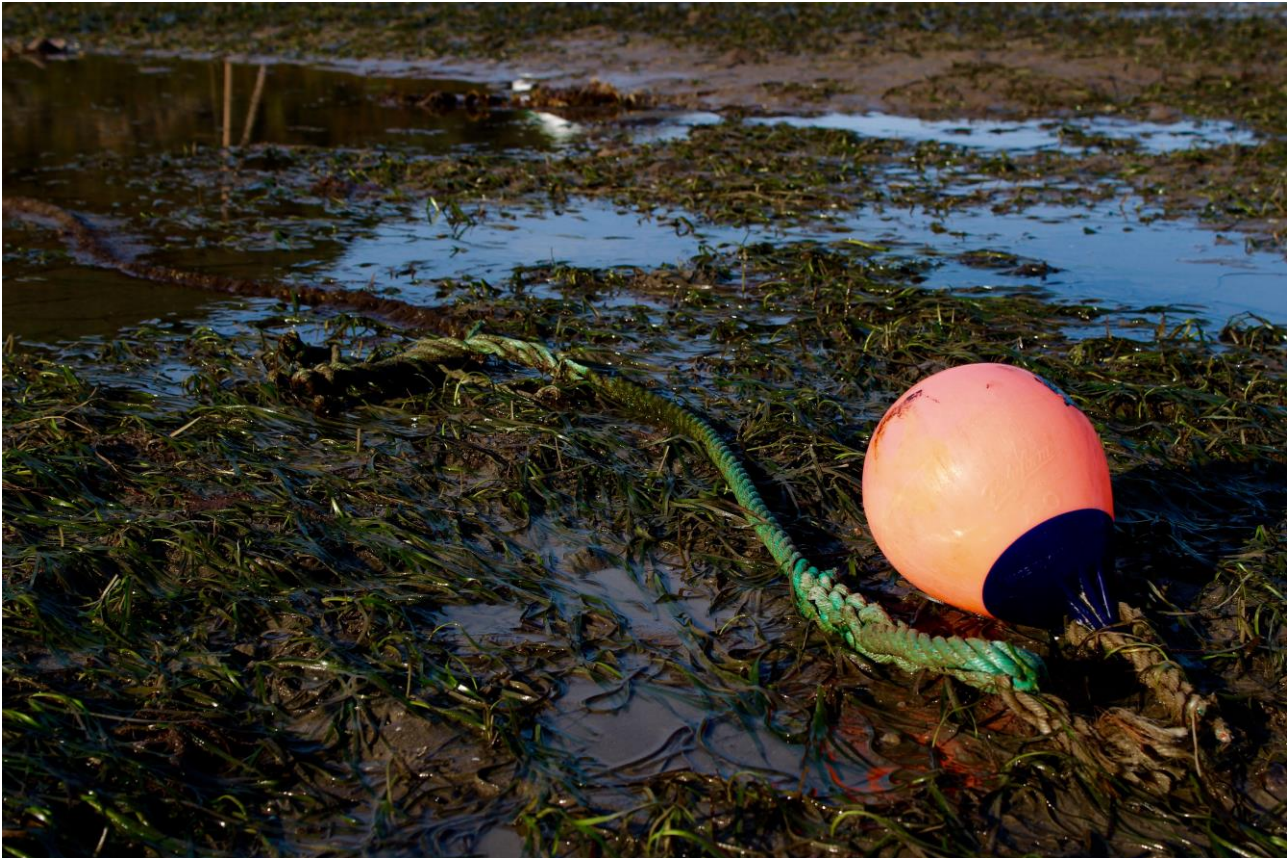
chain does. The absence of links within the rope also minimises tearing as the mooring moves. This approach has been used in Porthdinllaen where rope moorings were already in frequent use with positive results. It is worth considering that rope is likely the most feasible option for smaller vessels during summer months in sheltered conditions (e.g. where moorings are removed for winter).

Photo: Rope mooring in North Wales at low tide (Gwenan Griffith)

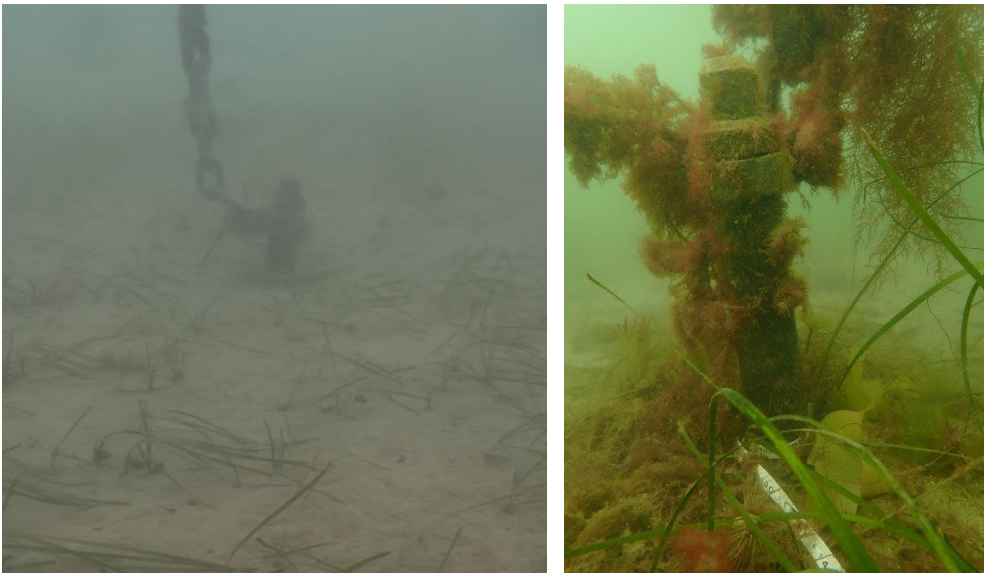
Photo: Helical screw anchor in place on boat mooring in Cawsand bay (Mark Parry, Ocean Conservation Trust (left image) and Natural England dive unit (right image))

- Annual inspection on subtidal moorings attached to helical screws requires divers (or cameras depending on visibility) as they cannot be hauled up.
- Helical screws are reported to have longer life spans (dependent on galvanisation and environmental conditions) and stronger holding power than traditional blocks.

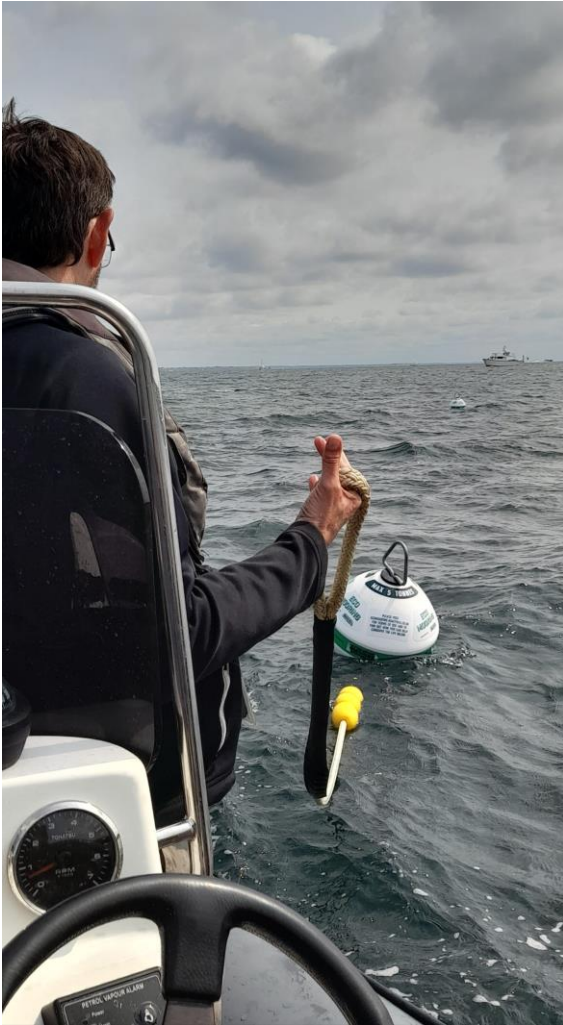
Consider use of pick-up lines for visitor moorings for ease of use. These are in place for the AMS visitor moorings following user feedback in Studland Bay <https://www.dorsetcoast.com/project/studland-bay-marine-partnership/>. Through chain top marks have been used on individual moorings in Cawsand as part of the ReMEDIES project to minimise the need for mooring users to add any additional lines which could cause instability.

Photo: Using a pick up line on a Hazelett mooring in Studland bay (Sara Parker- Dorset Council)

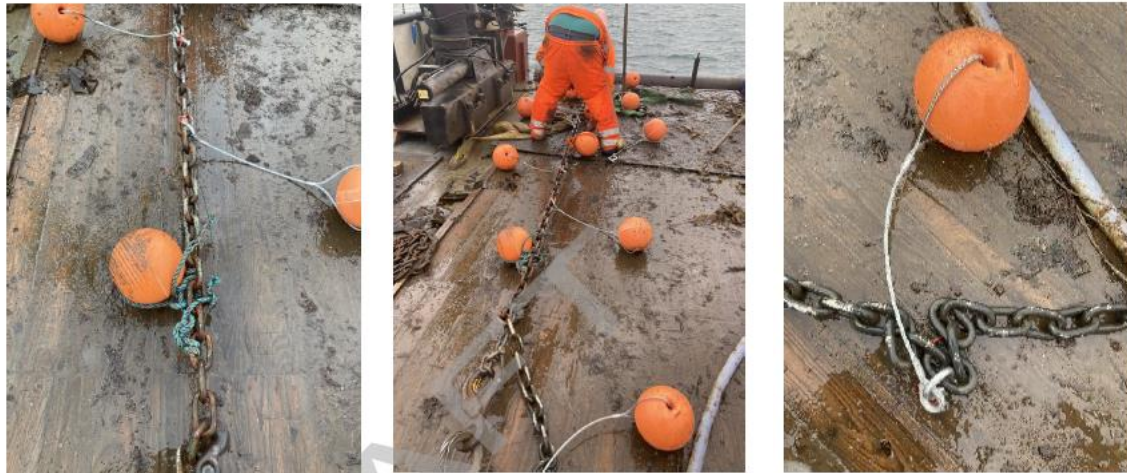
Another example of lessons learned during early installation is from a project in Strangford Lough, Northern Ireland where during the first year of Stirling AMS boat mooring trials, 5 of the float attachments failed leading to the chain dragging along the seabed. Failure was due to the deterioration of the rope ties attaching the net float buoys to both ground and rising chain. These ties were then replaced with 8mm galvanised wire attached to the chains with shackles.

Photo: Rope ties, and then replacement galvanise wire on Stirling type moorings in Strangford Lough (Dr Rachel Millar & Dr David Smyth (on behalf of Cuan Marine Services))

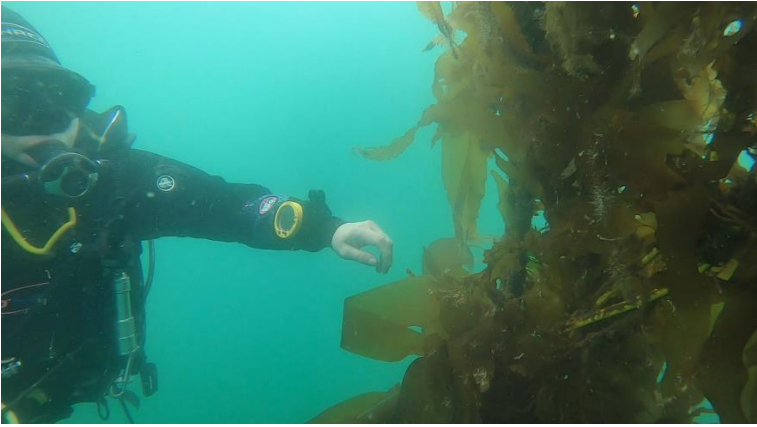
Anecdotal evidence from the ReMEDIES project team as well as those involved in trials in the Fal and Helford has highlighted the additional level of biofouling apparent on both Seaflex and Stirling type mooring systems. It is suggested that the extra equipment within the water column compared to a traditional chain mooring provides a greater surface area for fouling. One AMS owner in Cawsand reported that the midwater buoys attract significant weed – expressing concerns that this will add to the current drag and that maintenance costs may be higher to remove. There is also the potential risk of colonisation by marine invasive non-native species. Natural England divers surveying Seaflex moorings in Cawsand in 2022 noted species such as *Wakame* (*Undaria pinnatifida*), a type of invasive seaweed which often rapidly colonises new artificial structures.

Photo: Fouling on Seaflex mooring in Cawsand, Plymouth (NE dive unit, 2021)

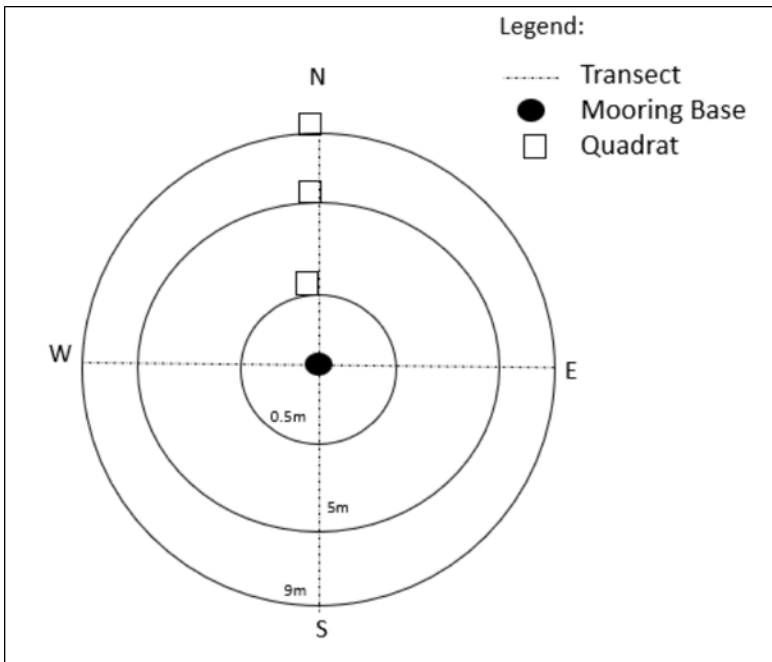
Divers enter the water in pairs, using the fixed mooring line and reel off the base of the mooring using a tape measure to 9m. Quadrat sampling at set distance intervals (9m, 5m, 0.5m) is carried out along each of four bearings (north, south, east and west) (see figure 2). A 0.25m² quadrat is placed on the right (or in some surveys on both sides) of the tape measure looking back towards the mooring line and the following measurements are taken:

1. Photograph of the quadrat
2. Number of individual plants counted within the quadrat
3. Percentage cover of seagrass
4. Percentage cover of algae
5. Canopy height (greatest length)
6. Estimate of sediment classification.

Figure 2: Diagram illustrating dive survey methodology around the central mooring point (Natural England)

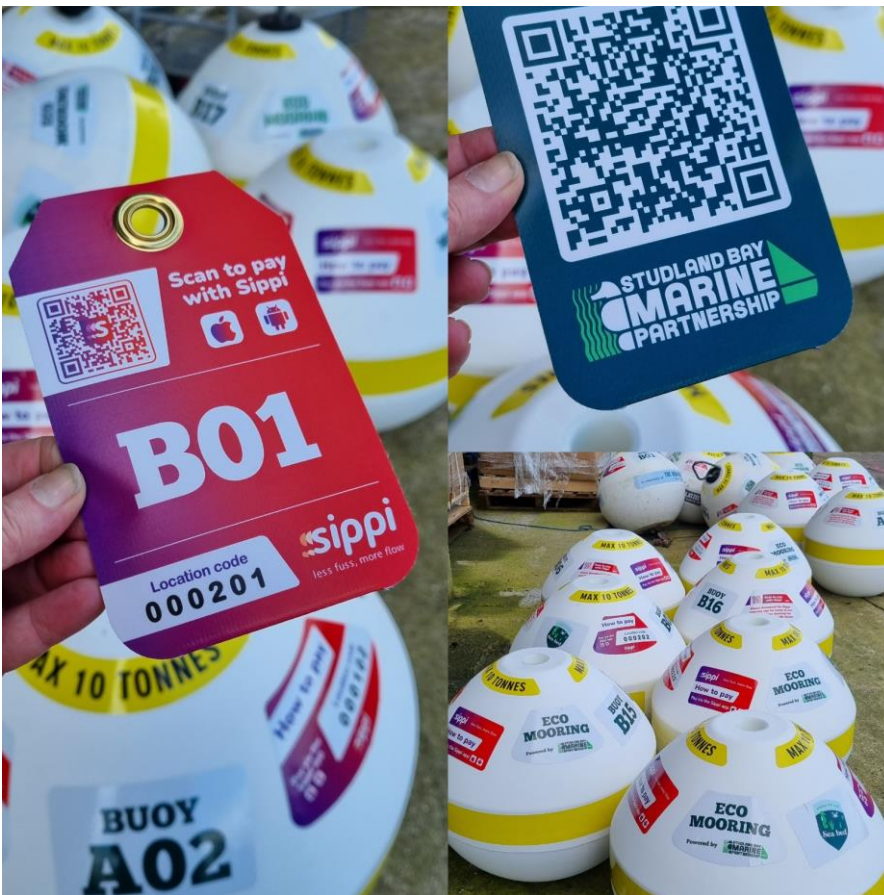
Photo: QR code use and payment information on Studland Bay AMS (Studland Bay Marine Partnership)

- Consider the information provided on an AMS – QR codes are useful to provide more information on the benefits of protecting sensitive habitats or to direct for further information. Seto and others (2024) suggest that increasing the visibility of the mooring as an environmentally friendly option could increase take up and use through promoting peer influence.

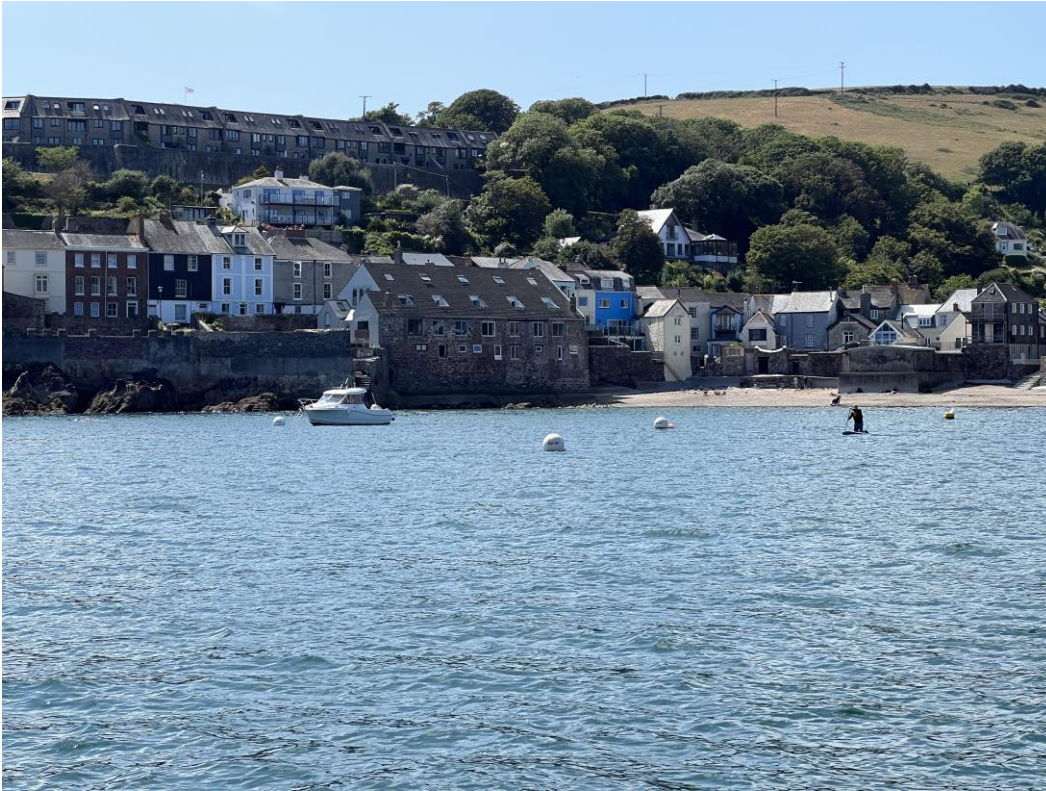
Photo: AMS in Cawsand Bay, Plymouth (Muriel Plaster, Natural England)

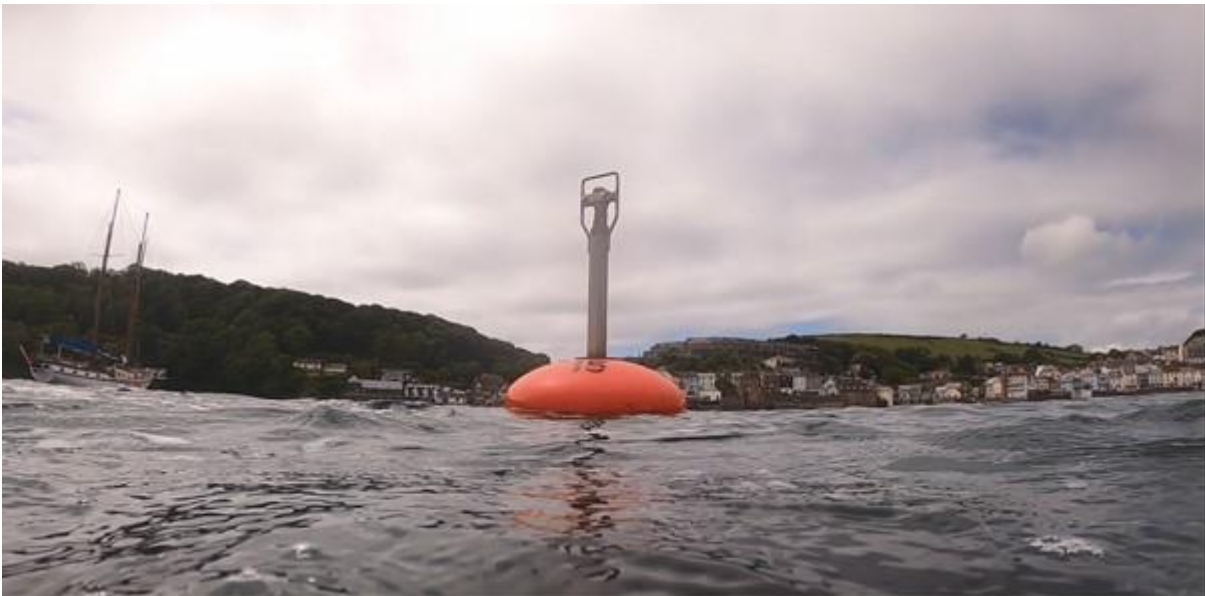
Photo: A Seaflex mooring in Cawsand Bay, Plymouth (NE dive team)

Furthermore, in 2023 a new owner took on the use of one of the Seaflex moorings and reported that the top buoy was causing issues scratching the boat hull. The Seaflex top buoy that was originally purchased is designed with a spar attached for ease of pick up. In discussion with Seaflex and the mooring contractor for advice, an alternative option will be provided. However, another Seaflex user has fed back that this type of top buoy with the spar actually works very well for their boat so it really does depend on user preference and the type of boat.

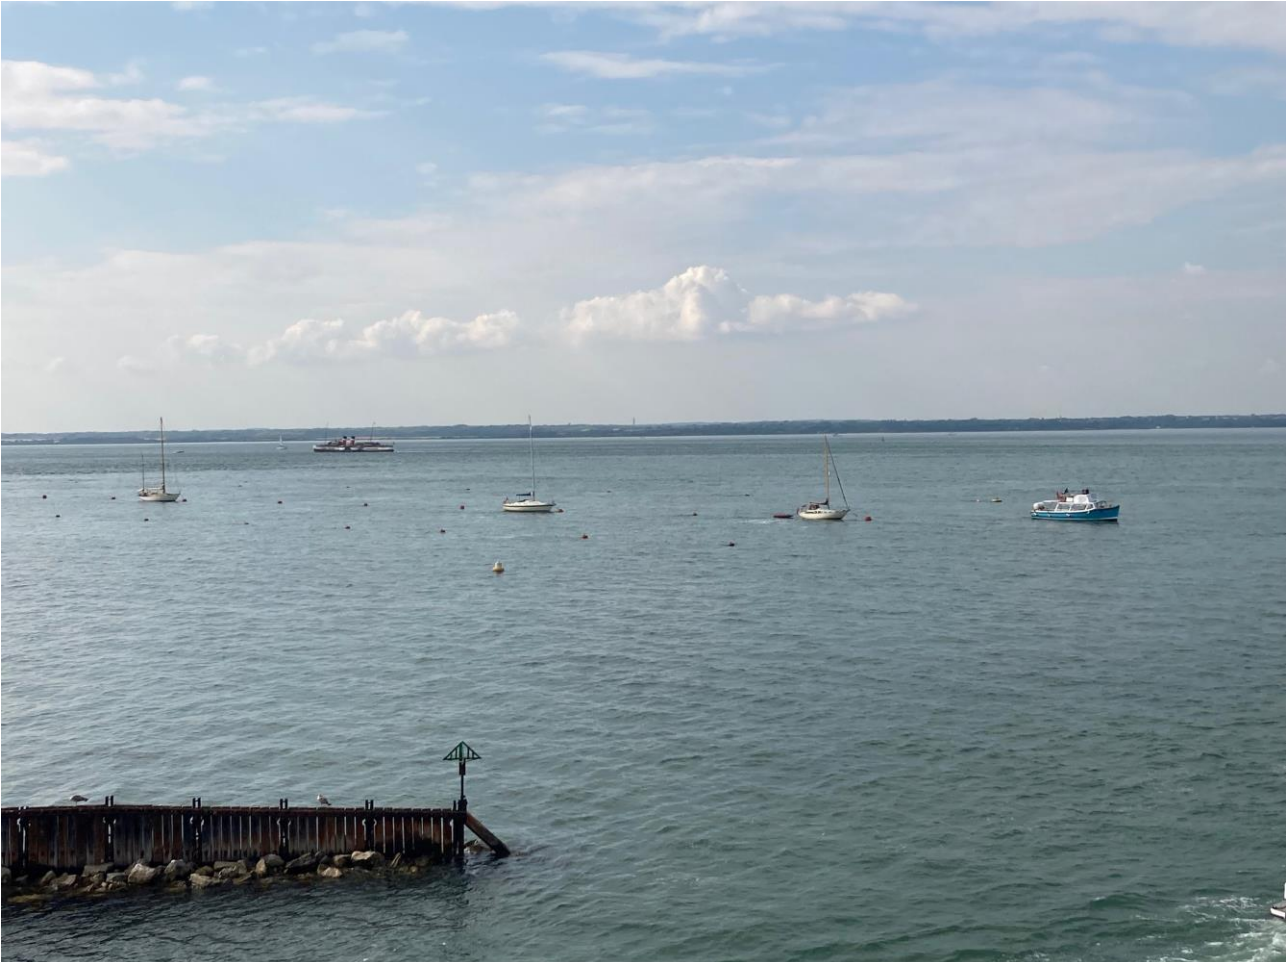
Photo: Stirling AMS on a trot mooring at Yarmouth Harbour (Caitlin Napleton, Natural England)

Following positive experience of using a Stirling mooring installed in 2020, a further 3 Stirling moorings were installed on the trot mooring in 2021. One issue that was reported was the shackles originally used deteriorated much quicker than expected, particularly the smaller shackles that attached the floats along the chain riser. An alternative high carbon material for the shackle was recommended and some chain/shackles were replaced as part of the maintenance of the moorings in 2024. In addition, in some very specific conditions at slack tide and certain winds, the boats on this line of AMS on the trot mooring have been bumping together. This has been an infrequent occurrence but the recommended solution has been to provide further space between the moorings.

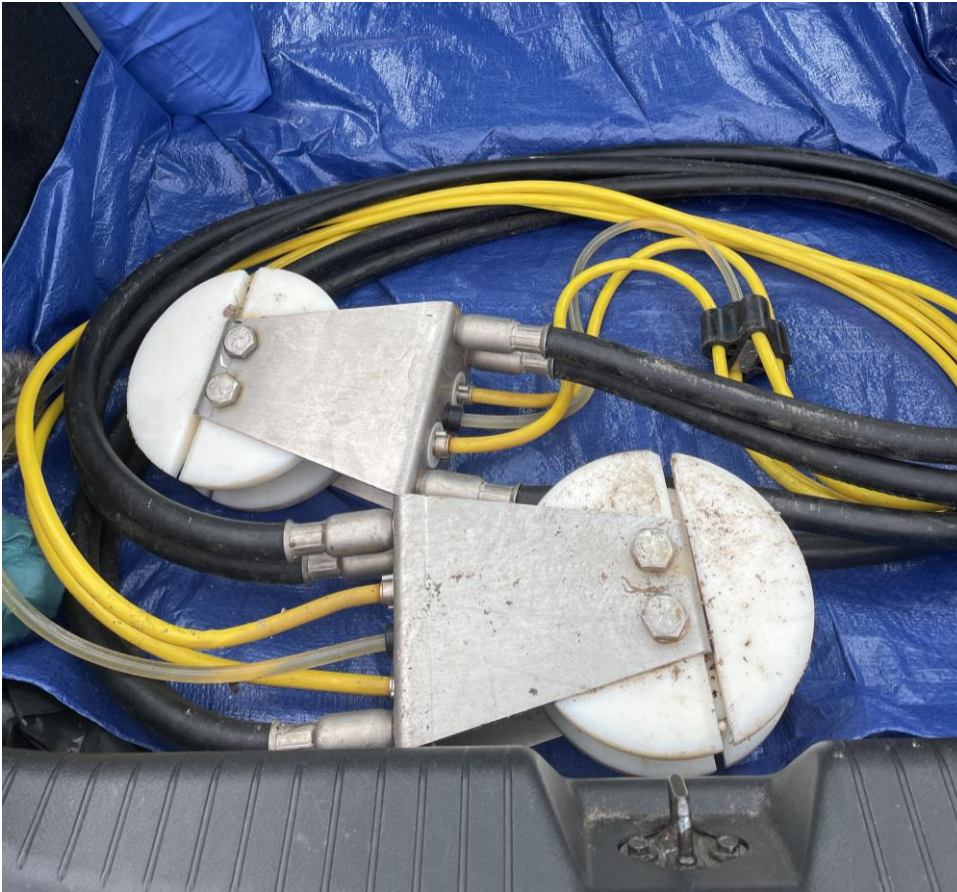
Photo: Seaflex destined for use in Essex instead (Jules Agate, Natural England)

- Installing Seaflex on a trot mooring with the chain as the anchor is not a standard solution for Seaflex mooring which are designed as swing moorings.

- Due to unfamiliarity with the system, the harbour authority had concerns about ability to withhold in large tidal height and strength in the area compared to use in more sheltered bays.

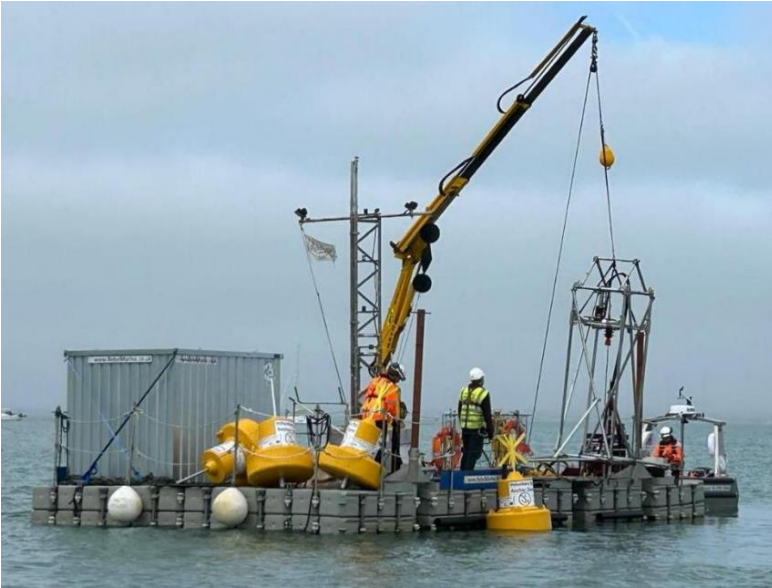
In order to install these markers, a Mooring Installation Tool that could be deployed from a barge without the need for divers was developed by specialist contractors, ABC Subsea consortium. A key advantage of not using divers is the ability to install in strong currents, improved efficiency and safer operations. Each installation is under an hour (including time to move the pontoon to each location) – once the installation tool is on the seabed it takes about 2 minutes to install.

Photo: Mooring installation tool (ABC Subsea consortium)

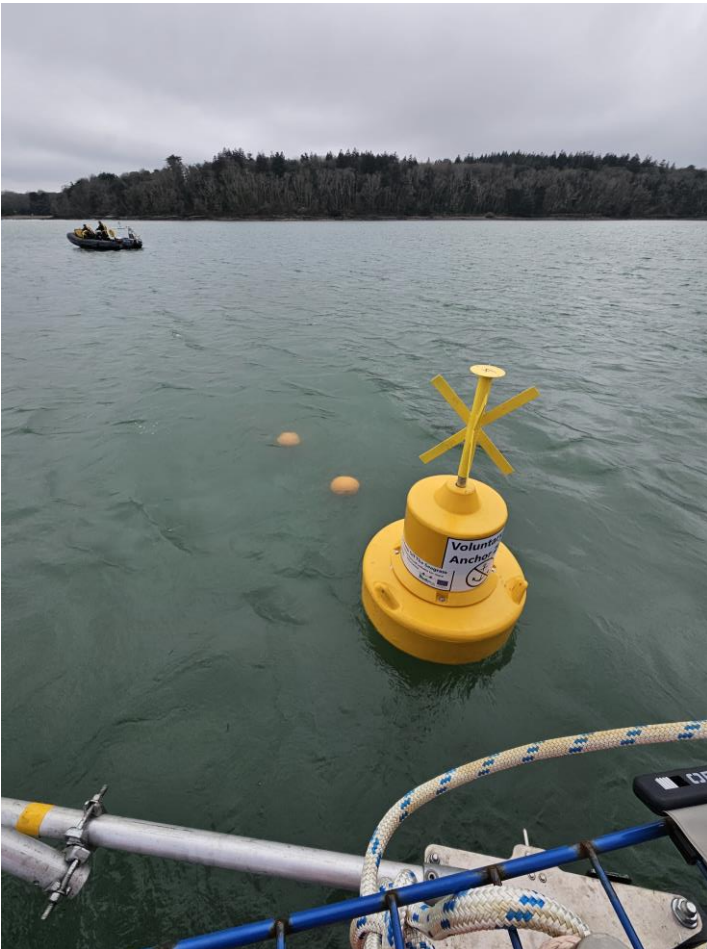
There were four existing moorings installed in Osborne Bay used to mark a 'Swimming area'. The moorings comprised a steel clump weight and a standard chain catenary and therefore did not protect the seagrass beds. The ReMEDIES project therefore needed to retrieve and remove these and replace them with 8 AMS which comprised a 2m long helical screw pile with integrated swivel attachment and a chain riser which uses floats to give it neutral buoyancy. The top buoys from the original four moorings were re-used as part of this installation.

Photo: VNAZ marker in the water (ABC Subsea consortium)
